INSPECTION REPORT FOR:

Date: March 7, 2025

Gulfshore Home Inspections, Inc
18008 Horseshoe Bay Circle,
Fort Myers FL 33967
(239) 949-1601
GulfshoreHI@comcast.net
www.GulfshoreHI.com

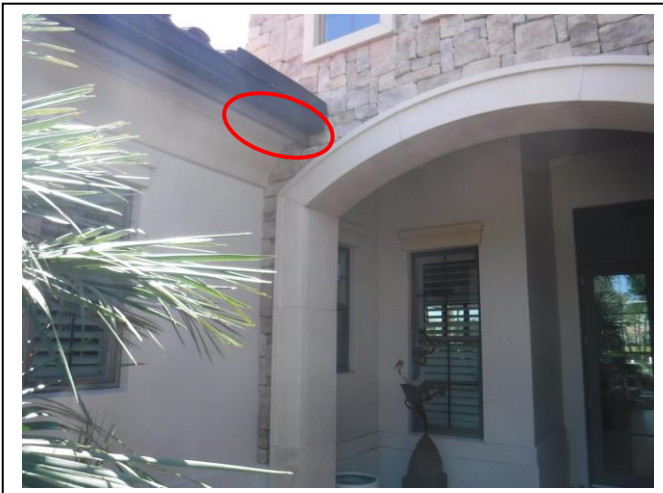
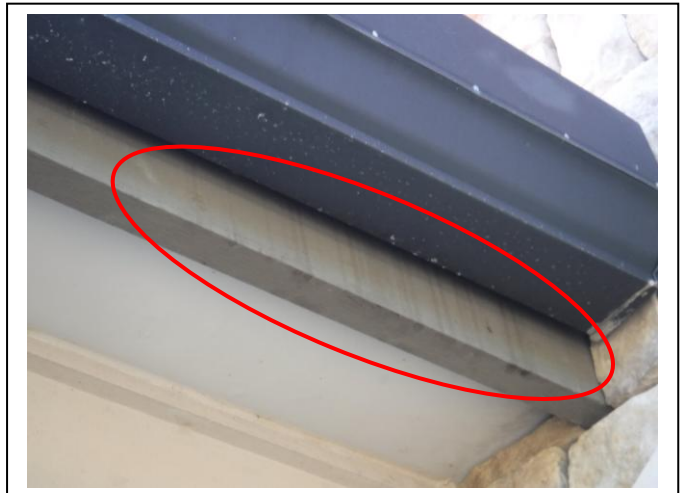
1. There are drip stains on the fascia board at the front entry. See the pictures below.

It is recommended that you have these areas further evaluated by a roofing contractor.

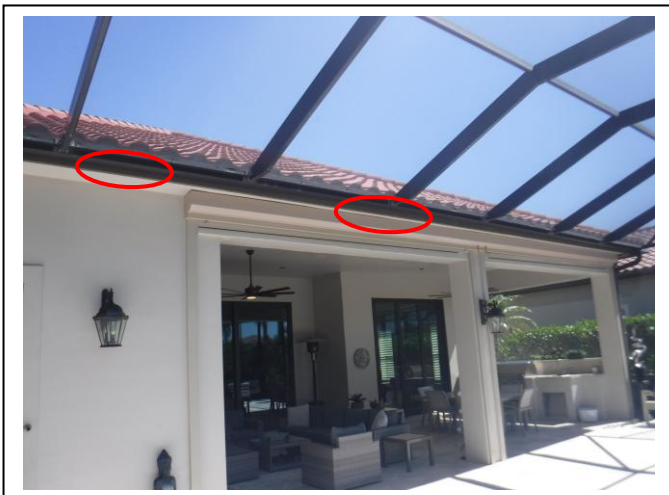
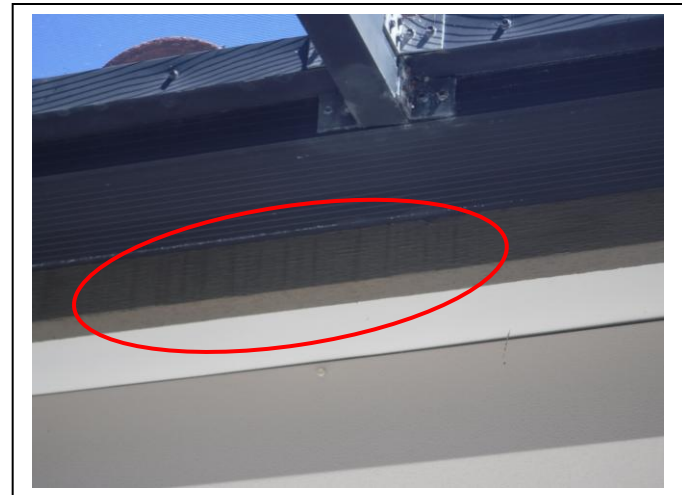
2. There are drip stains on the fascia board on the lanai. See the pictures below.

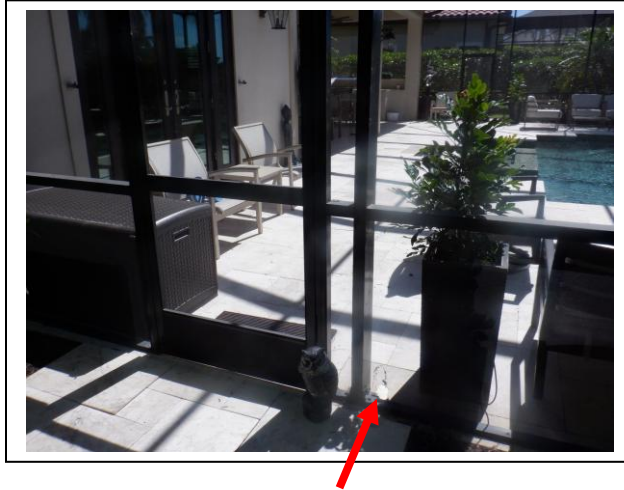
3. The pool cage left screen door handle lock does not work.
4. The pool cage right screen door drags on the pavers and cannot be completely opened.
5. There is a hole in the screen panel next to the right screen door. See the picture below for the location.

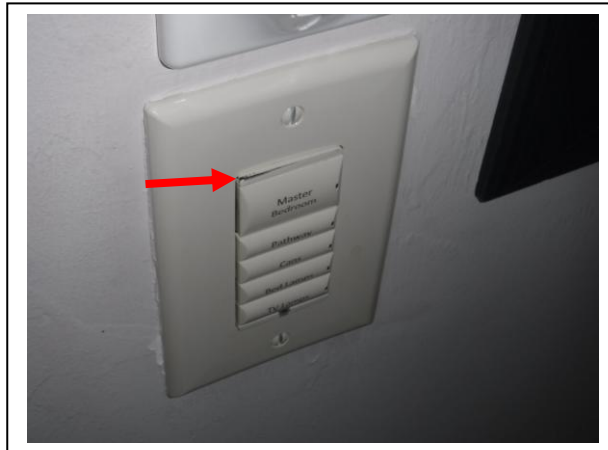
6. The master bedroom lighting control has a broken trim. See the picture below.

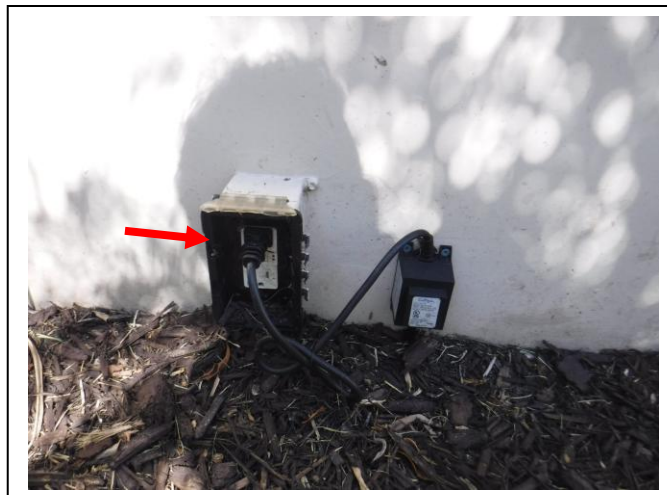
7. The exterior electrical outlet at the left rear corner of the home has a missing weatherproof cover. See the picture below.

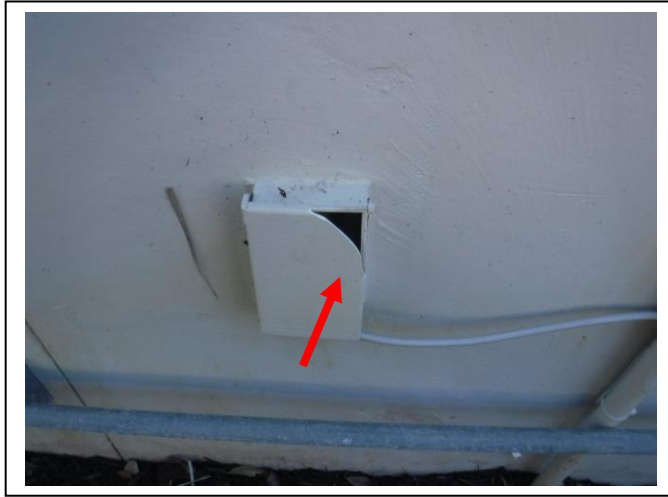
8. The exterior electrical outlet for the lawn sprinkler controller has a broken weatherproof cover. See the picture below.

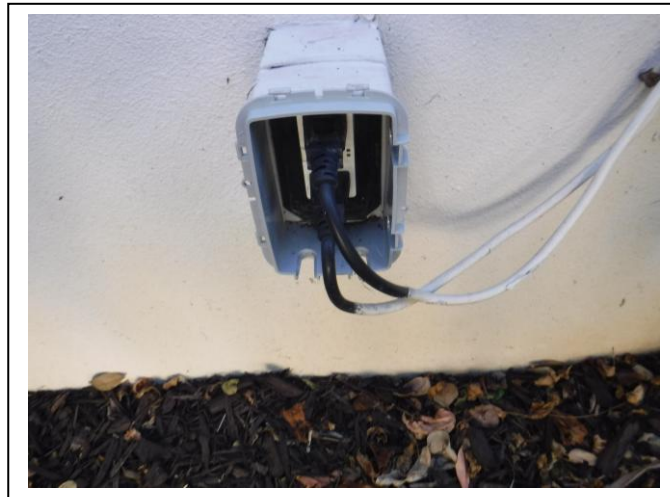
9. The exterior electrical outlet at the front right corner of the home is missing the weatherproof cover. See the picture below.

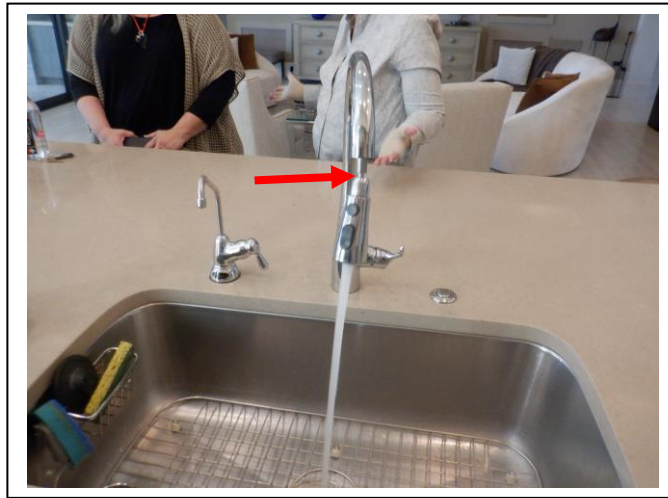
10. The kitchen sink faucet leaks at the ball joint. See the picture below.

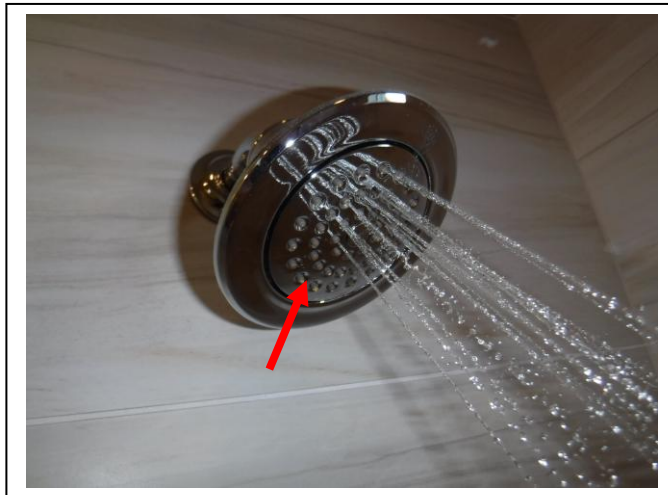
11. The hall bathroom showerhead is partially clogged. See the picture below.

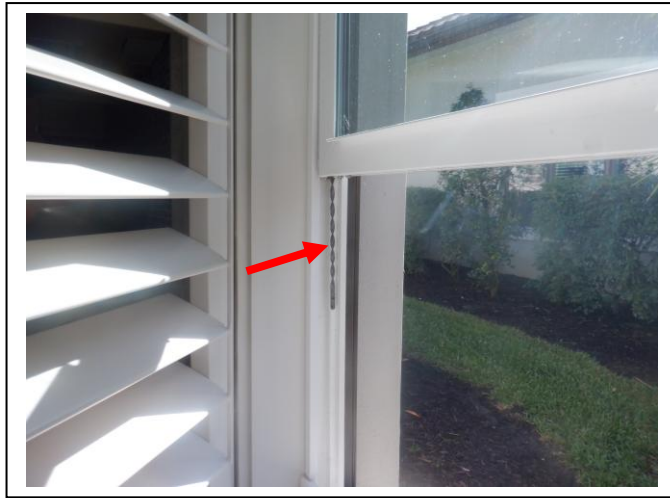
17. The breakfast nook windows have broken balance springs. See the picture below.

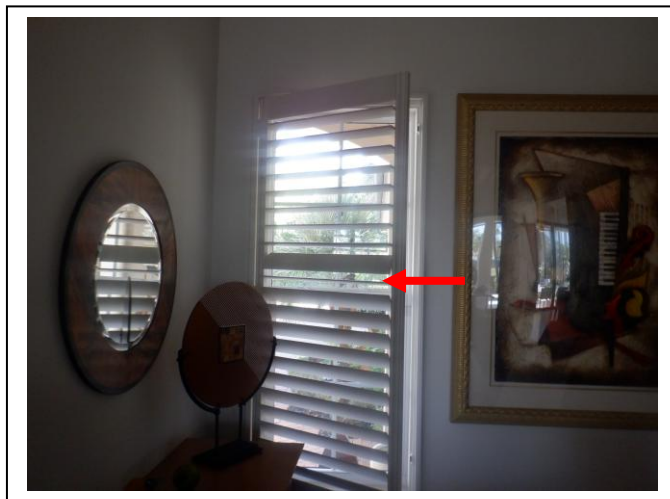
18. The dining room window plantation shutter has a broken slat. See the picture below.

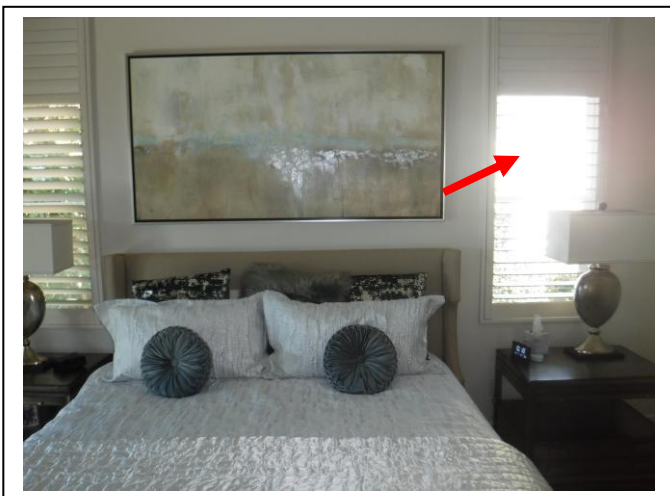
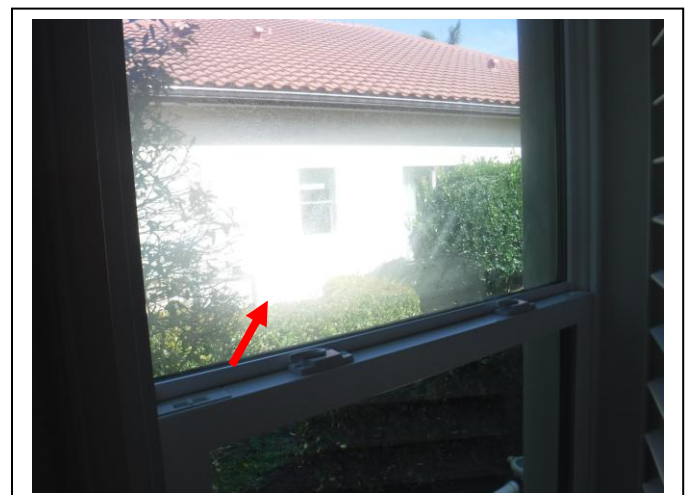
19. The master bedroom right window's top pane is fogged. This is an indication that the seal between the two panes of glass has failed. See the pictures below.

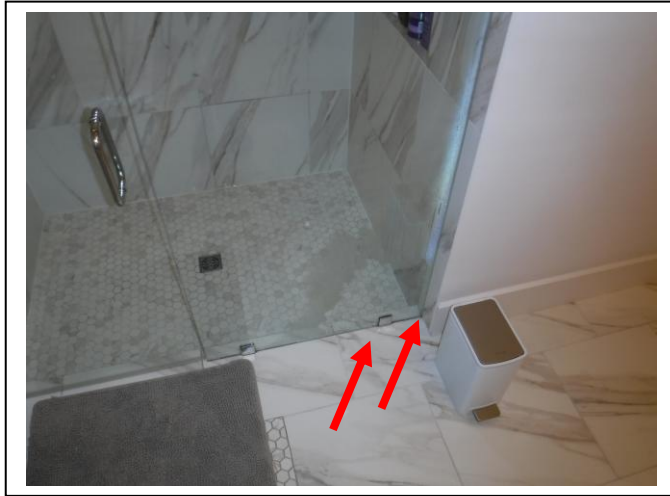
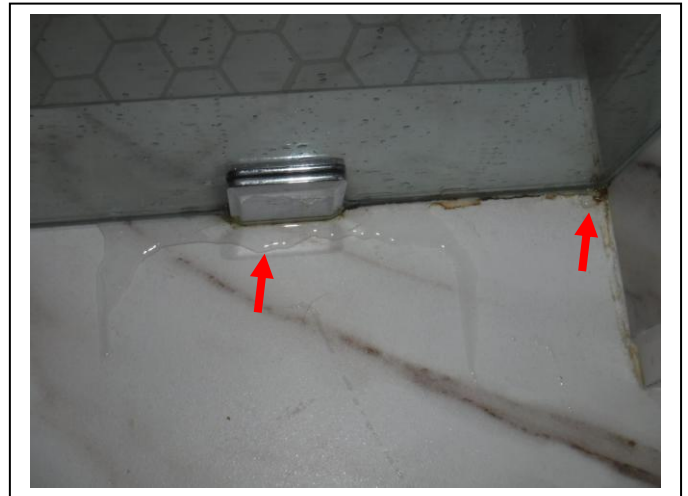
20. The master bathroom fixed shower panel leaks. See the pictures below.

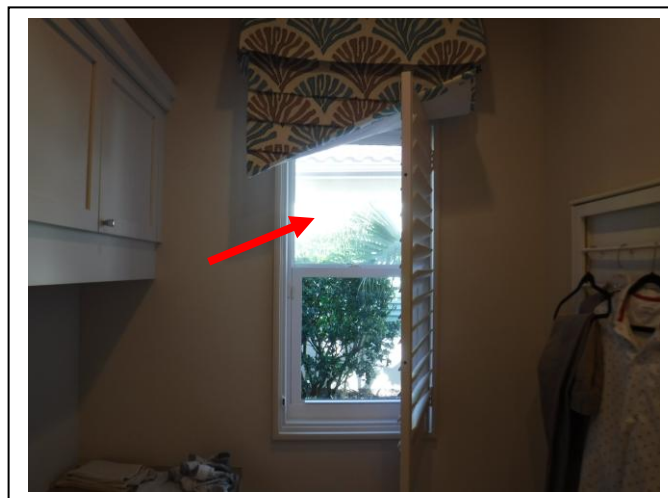
21. The laundry room window's top pane is fogged. See the picture below.

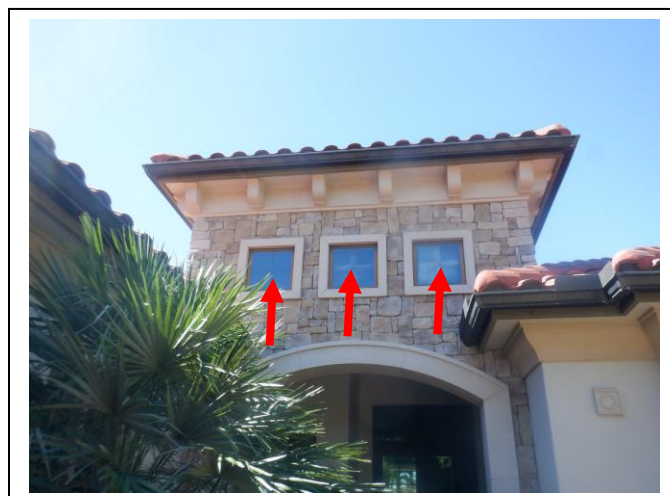
22. The three windows above the front entry door are fogged. See the picture below. It is recommended you have the window items further evaluated by a qualified window contractor.

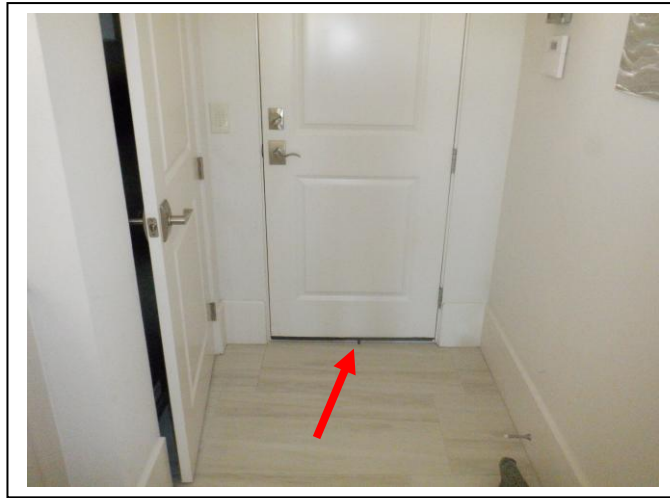
23. At the garage entry door into the home, the bottom sweep is torn. See the picture below.

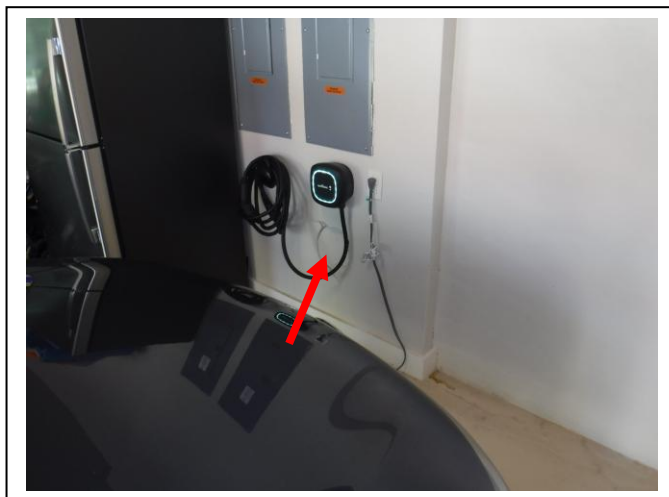
24. There is damaged drywall in the garage. See the picture below.

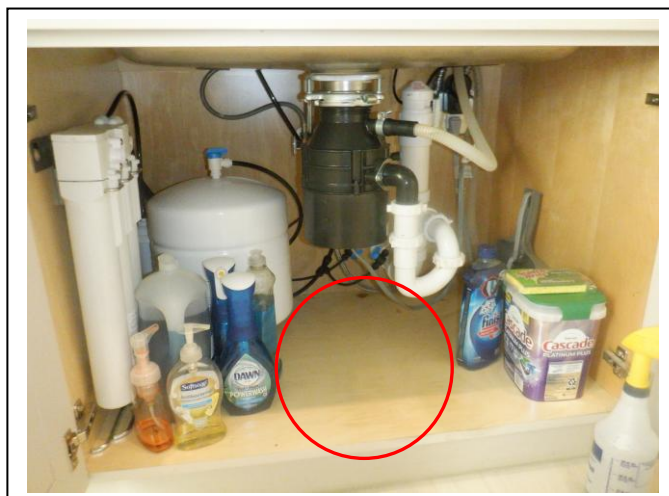
25. There is water staining on the kitchen sink cabinet floor. The area was dry and no leaks were discovered at this area. See the picture below.

It is recommended that you ask for disclosure of past issues or repairs at these areas.

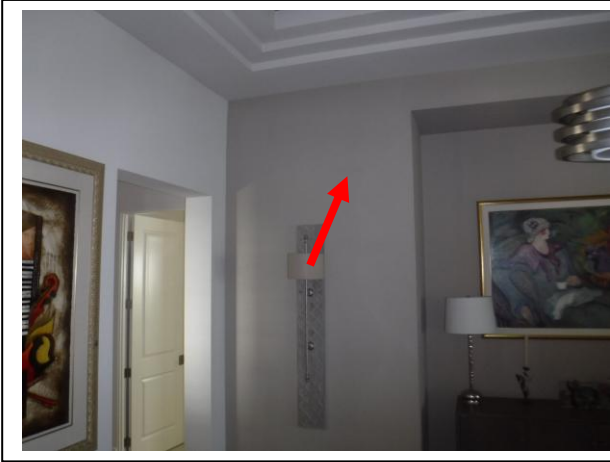
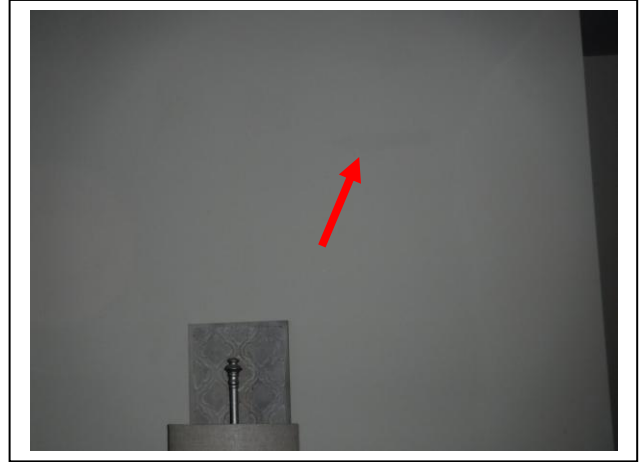
26. There is a stain on the dining room wall; the area was dry. It is unknown if this is moisture related. See the pictures below.

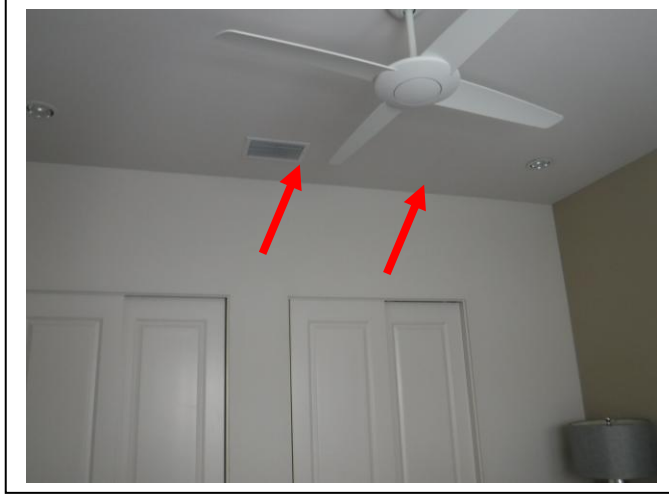
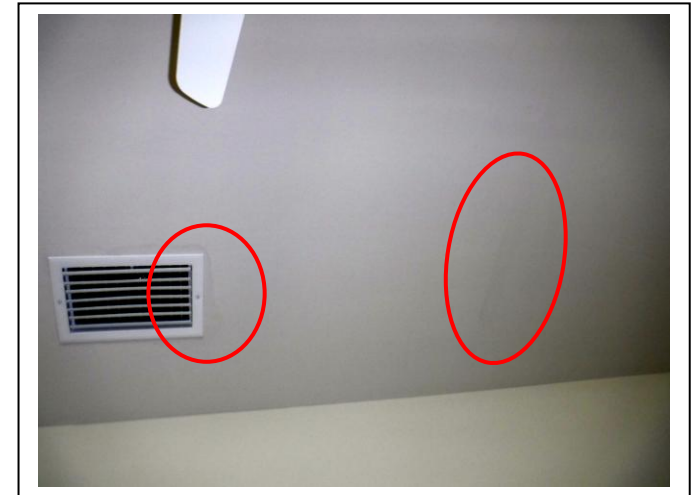
27. There are two water stains on the front left guest bedroom ceiling; the area was dry. This is near the a/c air handlers. The ceiling was dry at the time of the inspection. See the pictures below.

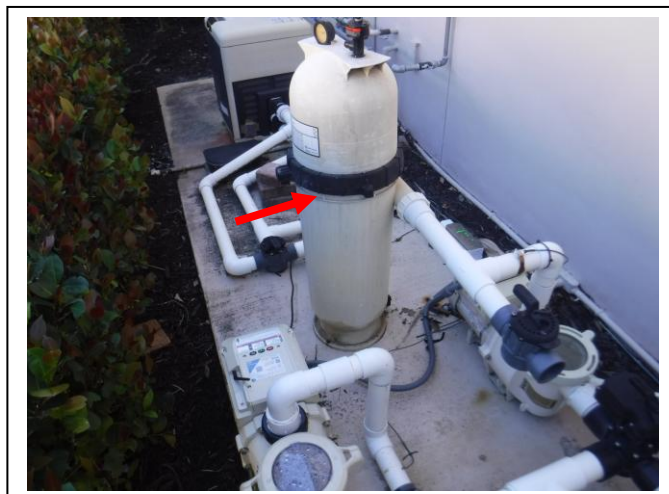
28. The pool filter leaks at the cap seal. See the picture below.

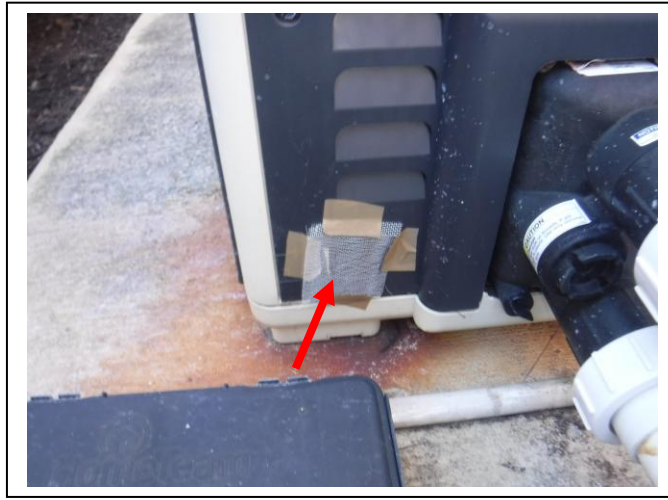
29. There is a hole in the pool heater case that is being patched by tape and screen. See the picture below.

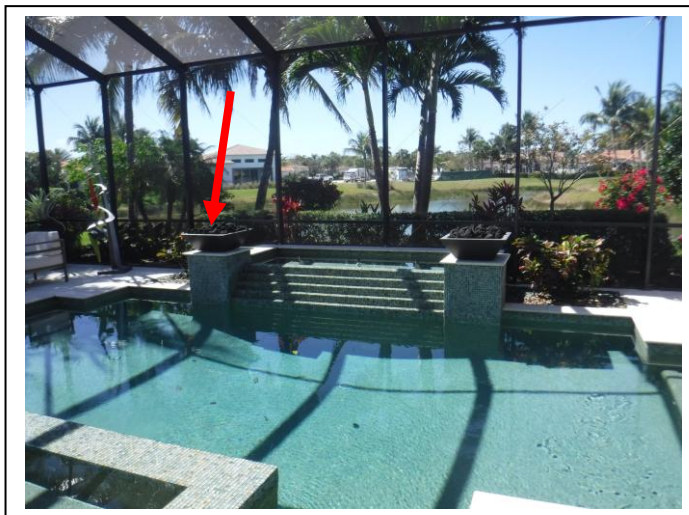
30. The left fire bowl did not work. See the picture below.
